# Well-Klean<sup>®</sup> Case Study

**Name/Location of Well:** ABC Well – Prescott, AZ Area

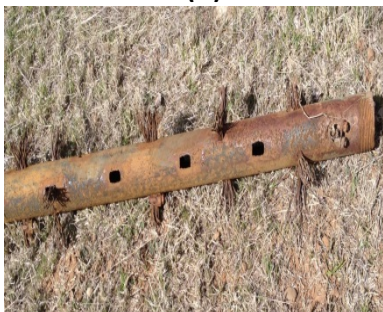
**Actions Taken:** Applied 50% of the Hydrogen Peroxide/Well-Klean<sup>®</sup> Pre-blend to the well followed by 30 minutes of brushing (A) each 10' of the perforated casing. Bailed reddish/black substance (B) dead biomass and iron bacteria from the bottom of the well until retrieving a sample of clean gravel pack. Applied the remaining 50% of the biocide and cleaner, swabbing the perforated casing in an attempt to force the chemical through the vertical slots and into the gravel pack. Applied 30 minutes of swabbing for each 10' of the perforated casing. Let the chemical soak in the well for 18 hours. Above ground, blended Sodium Bicarbonate powder with water, applied the water solution of the mixture to well and swabbed each 10' of the perforated casing vigorously for 15 minutes. Installed pump. Well produced a milky looking residue for 10-15 minutes before clearing. Well was re-developed for another 2-3 hours by surging. Disinfectant was added and the well was returned back to service.

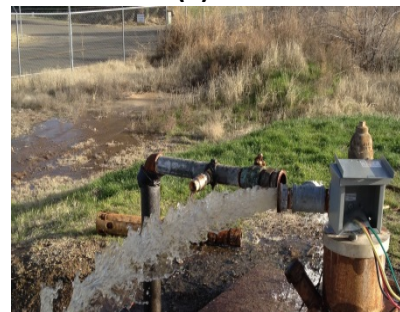
(C)

**Results:** Restored to 180 GPM (C). Static Water Level increased from 190' to 210'. Drawdown was reduced significantly.
