Well-Klean® Case Study

Name/Location of Well: Yavapai County – Near Oak Creek, AZ

Description/Well Dynamics: Irrigation

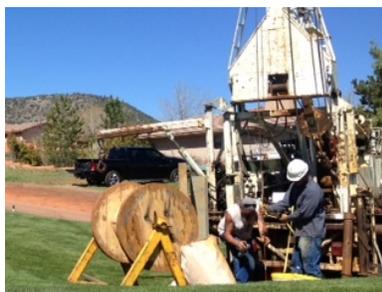
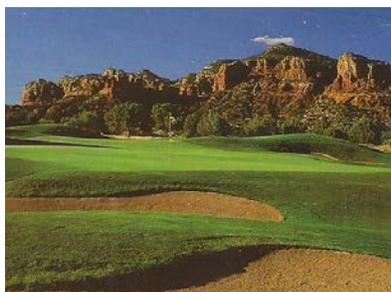
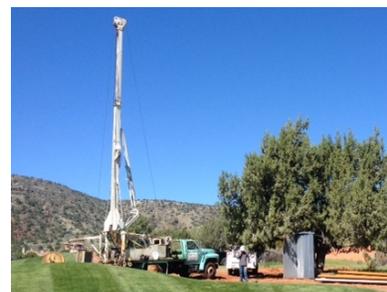
Photos:

Reason for Treatment: Well provides water to pond for golf course irrigation. Capacity for well had declined enough that irrigation from pond was not possible. Removed pump and downhole video revealed 75%-80% blockage of perforations by mineral scale, iron bacteria and some bio-films

Results: After treatment, post-video discovered previously hidden slots 100’ above the slots in well that were brushed. All slots were free and 100% open with no brushing. Well is producing more than adequate volume again.

Actions Taken: Applied 50% of the Hydrogen Peroxide/Well-Klean® Pre-blend to the well followed by 30 minutes of brushing of each 10’ of the perforated casing. Bailed all debris, dead biomass and iron bacteria from the bottom of the well until retrieving a sample of clean gravel pack. Applied the remaining 50% of the Well-Klean & biocide, swabbing the perforated casing in an attempt to force the chemical through the vertical slots and into the gravel pack. Applied 30 minutes of swabbing for each 10’ of the perforated casing. Let the chemical soak in the well for 18 hours. Above ground, blended Sodium Bicarbonate powder with water, applied the soda water solution to the well and swabbed each 10’ of the perforated casing vigorously for 15 minutes. Well was left for 2 days to settle before a post video was done. Pump was installed 2 days later. Well was re-developed for 2-3 hours by surging and continual pumping to the pond. The well was returned back to service.
