PARKVILLE WATER DISTRICT WELL REHAB

Central Pump Company
Center, CO

September, 2015

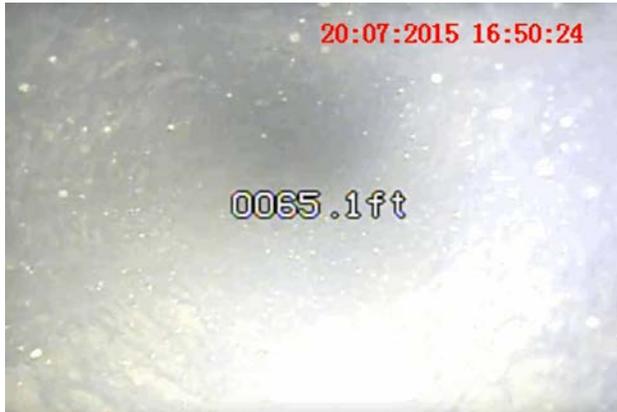
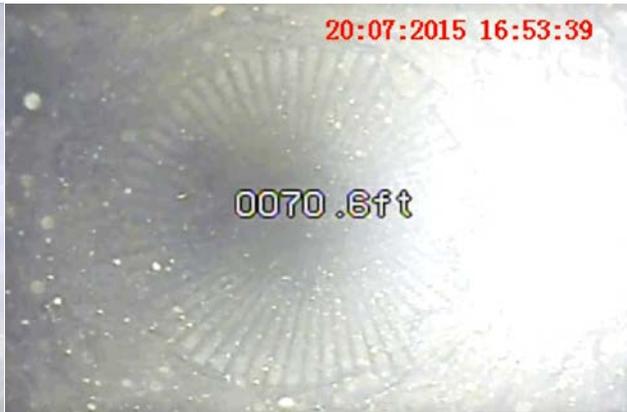
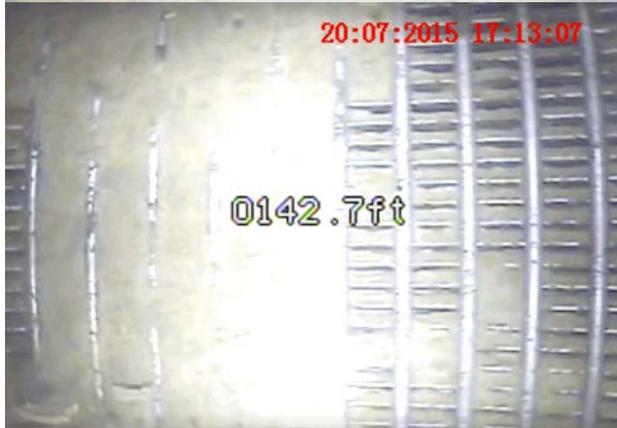
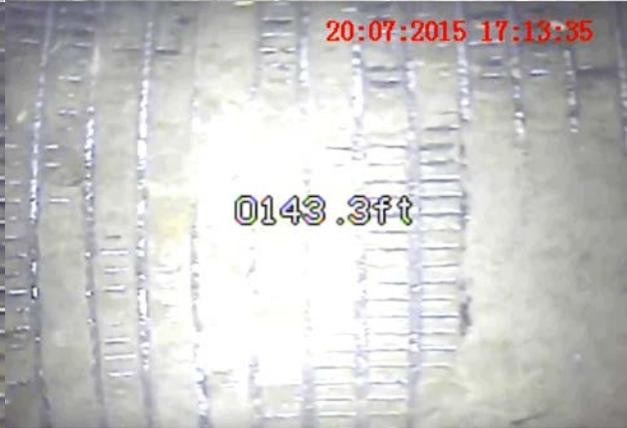
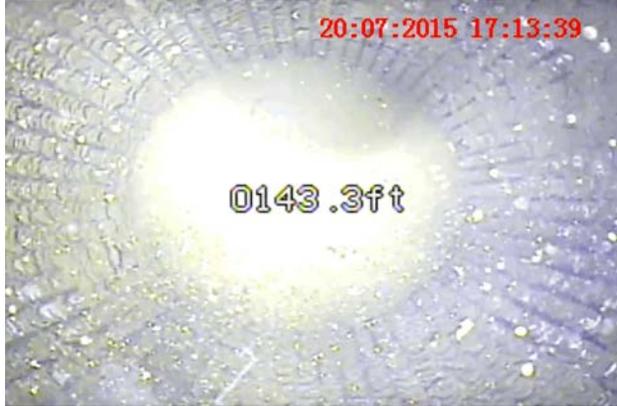
Well Screen Video Images Prior to Cleaning:

- 1.) A significant portion of the pump bolts were deteriorated and broken allowing the bowls to separate slightly and not hold pressure.
- 2.) The well test revealed a low specific capacity producing only 4.5 gallons per foot.
- 3.) The video of the well revealed serious blockage of the screen.

- 1.) Replaced Pump with a 14 stage 8LC American Marsh A trim impellers. The condition of the bolts were so bad separation the bowls would prove to be cost prohibitive and result in damage to the bowls and ultimately the bowls would need to be replaced
- 2.) Rehab the well. The combination of the test pump and video of the well provided us with the information to rehab the well.

The well rehabilitation chemicals, processes and procedures were as prescribed in accordance with the Well-Klean® Program by HercChemTech, LLC.

The well rehabilitation improved the performance of the well dramatically. The chemicals and processes cleaned the screen of the scale and bacteria, opening the screen to allow more water into the well. Specific capacity is the calculation used to evaluate the performance of the well. The average specific capacity of the well before cleaning was 4.49 and after the cleaning 5.15. A 13% increase in the wells ability to develop water was realized. The well now has the ability to develop 5.15 gallons per foot of water as opposed to 4.49 gallons.
